**Flood Control Project Maintenance
Levee Inspections**

2016 Channel Summary Report

Fairfield Suisun Sewer District

Levee Inspection Report By Mile - Channel 2016

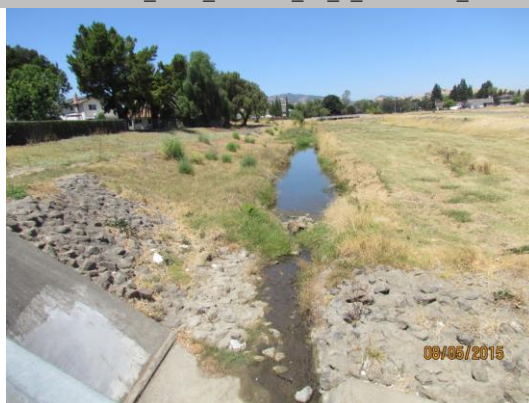
Photo 3 of 3 : CH_2016_NA0035_15_1_20160620_00001.jpg

View of Laurel Creek looking upstream. Summer 2015.

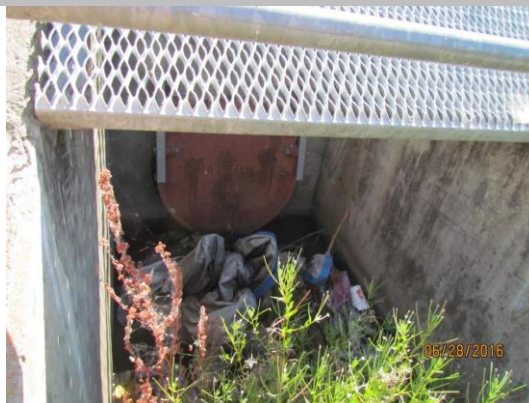
Photo 1 of 1 : CH_2016_NA0035_15_91_20160629_00046.jpg

Inspector Comments: There are signs of debris but does not seem to obstruct the function of the gate.

View of the gate located on the upstream part of Laurel Creek from Cement Hill Rd. Summer 2016.

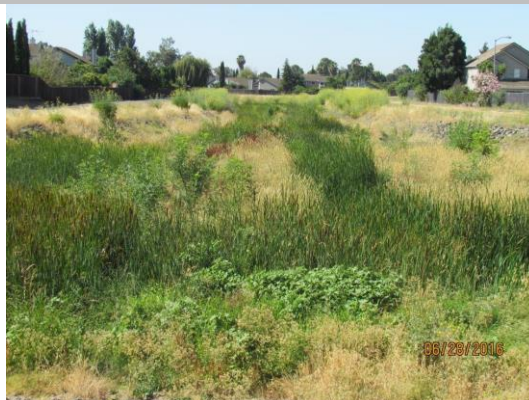
Photo 1 of 2 : CH_2016_NA0035_15_6_20160629_00049.jpg

Rating **	M	Issue No.	6	GPS Lat/Long
Issue Type +	Ma	Location *		38.279937 °
Category	Rivers, Channels & Designated Flood			-122.018353 °
Item	Vegetation & Obstructions			
DWR ID	DWR_NA0035_15_c_2012_6			
Action/Comments				
Inspector Comments: Cattails need to be removed.

View of the creek looking downstream from Cement Hill Rd. Summer 2016.

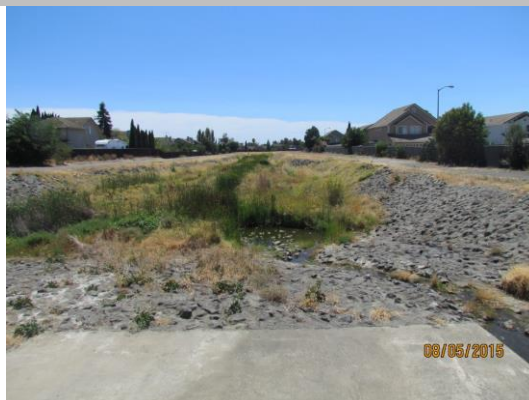
Photo 2 of 2 : CH_2016_NA0035_15_6_20160620_00003.jpg

Looking downstream from Cement Hill Rd. Summer 2015.

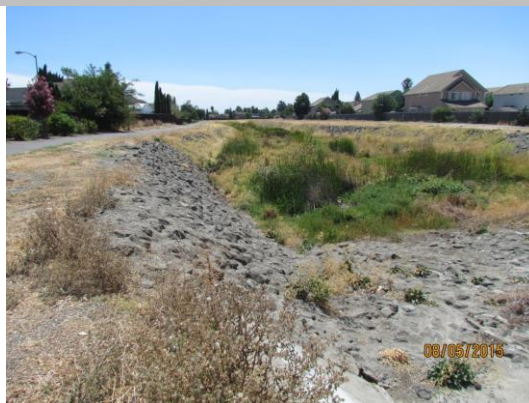
Photo 1 of 1 : CH_2016_NA0035_15_9_20160620_00005.jpg

Inspector Comments: Existing riprap protection is properly maintained and is undamaged. Riprap clearly visible.

View of revetment on the left bank looking downstream. Summer 2015.

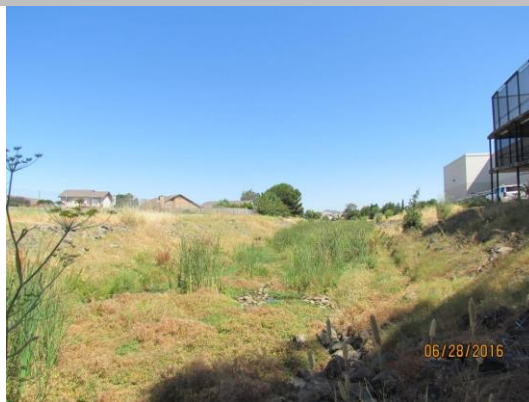
Photo 1 of 2 : CH_2016_NA0035_15_11_20160629_00050.jpg

Rating **	A	Issue No.	11	GPS Lat/Long
Issue Type +	Ma	Location *		38.272637 °
Category	Rivers, Channels & Designated Flood			-122.016114 °
Item	Vegetation & Obstructions			
DWR ID	DWR_NA0035_15_c_2012_11			
Action/Comments				
Inspector Comments: Minimal, scattered obstructions or vegetation. The flow is not impeded.

View of the creek looking upstream towards Cement Hill Rd. Summer 2016.

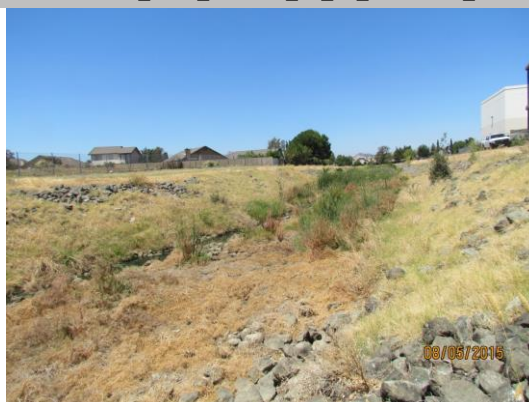
Photo 2 of 2 : CH_2016_NA0035_15_11_20160620_00006.jpg

Looking upstream from Air Base Pkwy. Summer 2015.

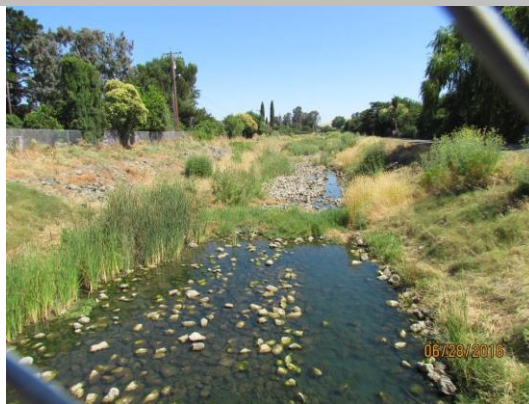
Photo 1 of 2 : CH_2016_NA0035_15_21_20160629_00052.jpg

Rating **	A	Issue No.	21	GPS Lat/Long
Issue Type +	Ma	Location *		38.268244 °
Category	Rivers, Channels & Designated Flood			-122.017216 °
Item	Vegetation & Obstructions			
DWR ID	DWR_NA0035_15_c_2012_21			
Action/Comments				
Inspector Comments: Minimal, scattered obstructions or vegetation. The flow is not impeded. The palm trees should be removed.

View of the creek looking upstream towards Air Base Pkwy. Summer 2016.

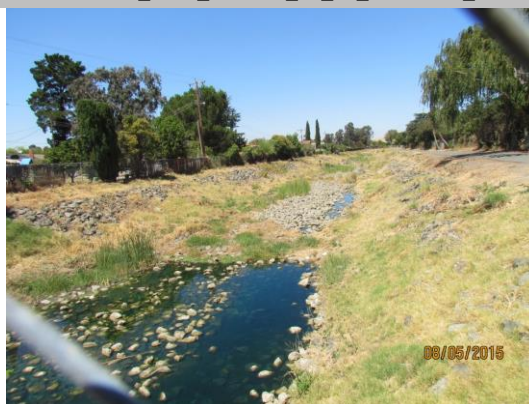
Photo 2 of 2 : CH_2016_NA0035_15_21_20160620_00010.jpg

Looking upstream from Meadowlark Dr. Summer 2015.

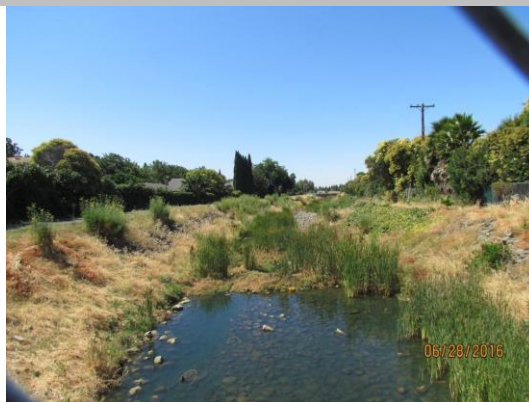
Photo 1 of 2 : CH_2016_NA0035_15_26_20160629_00053.jpg

Rating **	A	Issue No.	26	GPS Lat/Long
Issue Type +	Ma	Location *		38.268245 °
Category	Rivers, Channels & Designated Flood			-122.017216 °
Item	Vegetation & Obstructions			
DWR ID	DWR_NA0035_15_c_2012_26			
Action/Comments				
Inspector Comments: Minimal, scattered obstructions or vegetation. The flow is not impeded.

View of the creek looking downstream from Meadowlark Dr. towards E. Tabor Ave. Summer 2016.

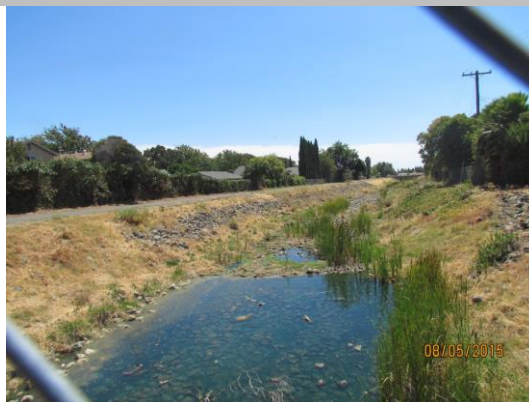
Photo 2 of 2 : CH_2016_NA0035_15_26_20160620_00012.jpg

Looking downstream from Meadowlark Dr. Summer 2015.

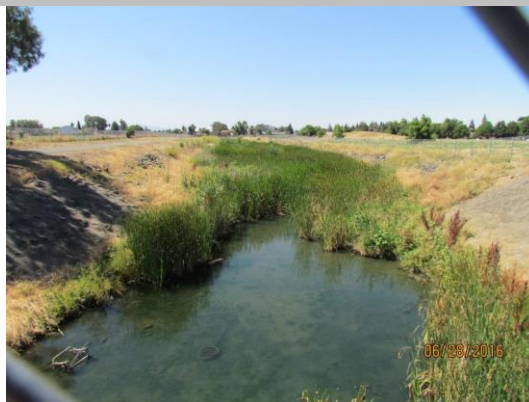
Photo 1 of 2 : CH_2016_NA0035_15_36_20160629_00055.jpg

Rating **	A	Issue No.	36	GPS Lat/Long
Issue Type +	Ma	Location *		38.265401 °
Category	Rivers, Channels & Designated Flood			-122.018316 °
Item	Vegetation & Obstructions			
DWR ID	DWR_NA0035_15_c_2012_36			
Action/Comments				
Inspector Comments: Minimal, scattered obstructions or vegetation. The flow is not impeded.

View of the channel looking downstream towards Matthew Dr. from E. Tabor Ave. Summer 2016.

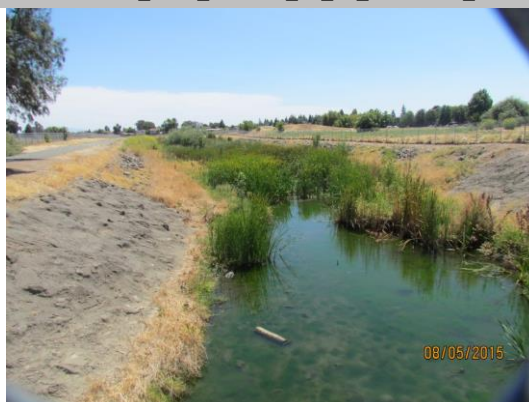
Photo 2 of 2 : CH_2016_NA0035_15_36_20160620_00018.jpg

Looking downstream from E. Tabor Ave. Summer 2015.

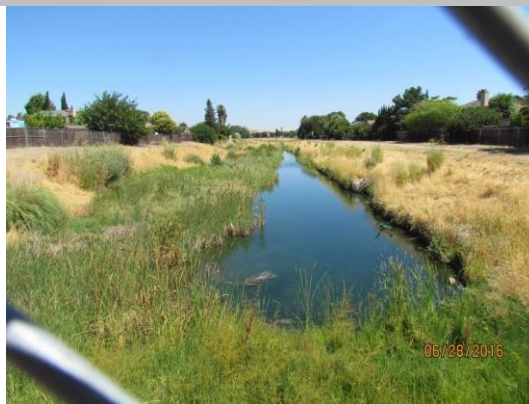
Photo 1 of 2 : CH_2016_NA0035_15_41_20160629_00056.jpg

Rating **	A	Issue No.	41	GPS Lat/Long
Issue Type +	Ma	Location *		38.259229 °
Category	Rivers, Channels & Designated Flood			-122.017713 °
Item	Vegetation & Obstructions			
DWR ID	DWR_NA0035_15_c_2012_41			
Action/Comments				
Inspector Comments: Minimal, scattered obstructions or vegetation. The flow is not impeded.

View of the channel looking upstream towards East Tabor Ave. from Matthew Rd. Summer 2016.

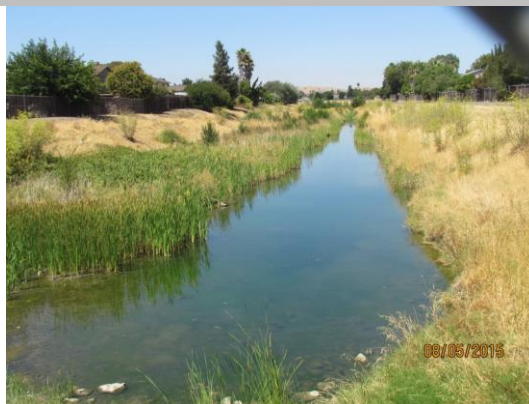
Photo 2 of 2 : CH_2016_NA0035_15_41_20160620_00020.jpg

Looking upstream from Matthew Rd. Summer 2015.

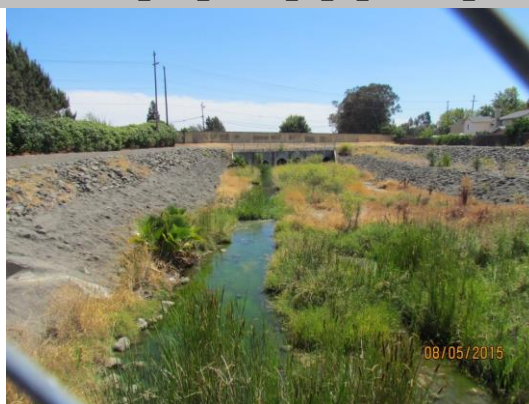
Photo 2 of 2 : CH_2016_NA0035_15_46_20160620_00022.jpg

Rating **	A	Issue No.	46	GPS Lat/Long
Issue Type +	Ma	Location *		38.259272 °
Category	Rivers, Channels & Designated Flood			-122.017533 °
Item	Vegetation & Obstructions			
DWR ID	DWR_NA0035_15_c_2012_46			
Action/Comments				
Inspector Comments: This area is the same as upstream Railroad Avenue. I recommend the removal of the volunteer palm trees.

Looking downstream from Matthews Rd. Pipe goes under the railroad. Summer 2015.

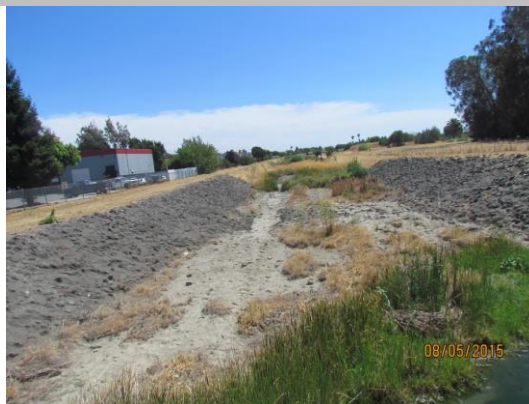
Photo 2 of 2 : CH_2016_NA0035_15_56_20160620_00024.jpg

Looking downstream from Railroad Ave. Summer 2015.

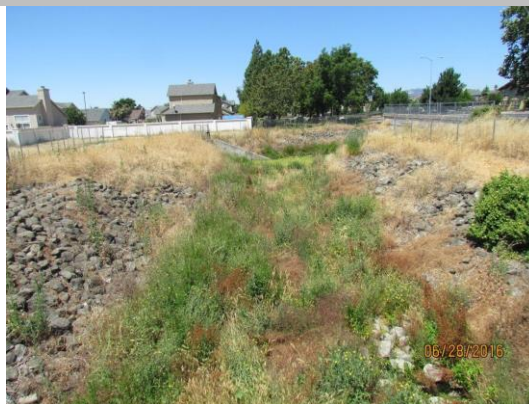
Photo 1 of 2 : CH_2016_NA0035_15_61_20160629_00059.jpg

Rating **	A	Issue No.	61	GPS Lat/Long
Issue Type +	Ma	Location *		38.253525 °
Category	Rivers, Channels & Designated Flood			-122.019984 °
Item	Vegetation & Obstructions			
DWR ID	DWR_NA0035_15_c_2012_61			
Action/Comments				
Inspector Comments: Minimal scattered obstructions or vegetation. The flow is not impeded.

View of the channel looking upstream. Summer 2016.

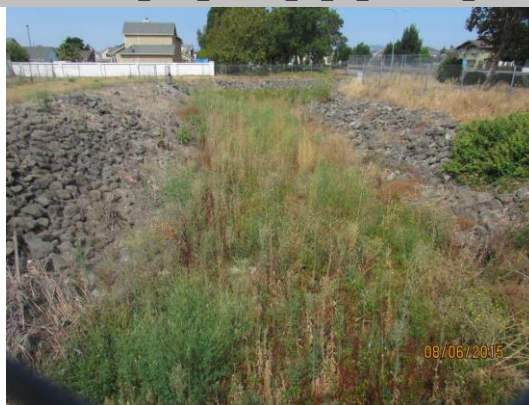
Photo 2 of 2 : CH_2016_NA0035_15_61_20160620_00026.jpg

Looking upstream from Sunset Ave. Summer 2015.

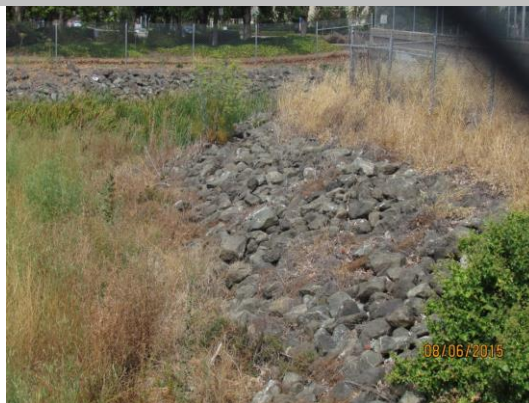
Photo 2 of 3 : CH_2016_NA0035_15_64_20160620_00028.jpg

Rating **	M	Issue No.	64 (cont)	GPS Lat/Long
Issue Type +	Ma	Location *		38.253525 °
Category	Rivers, Channels & Designated Flood			-122.019984 °
Item	Revetments			
DWR ID	DWR_NA0035_15_c_2012_64

View of the revetment on the left bank looking upstream. Summer 2015.

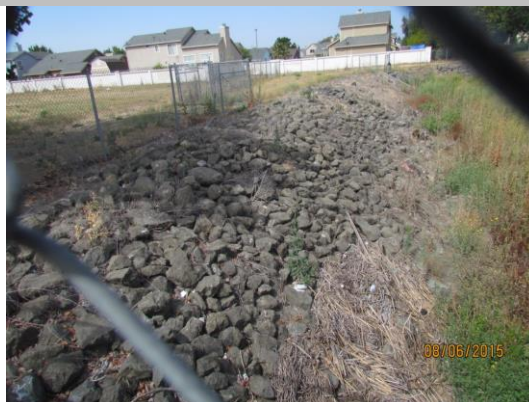
Photo 3 of 3 : CH_2016_NA0035_15_64_20160620_00029.jpg

Inspector Comments: Riprap displacement or scouring activity. Unwanted vegetation must be cleared and sprayed with an appropriate herbicide.

View of the revetment on the right bank looking upstream. Summer 2015.

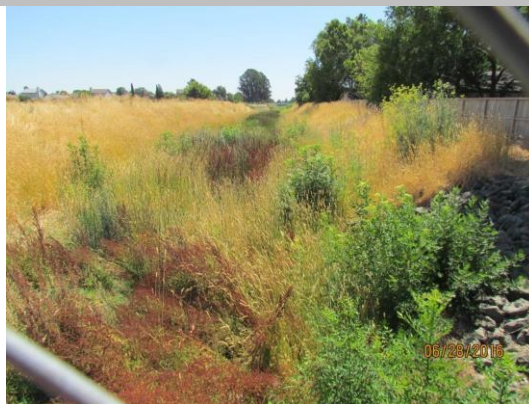
Photo 1 of 3 : CH_2016_NA0035_15_66_20160629_00061.jpg

Rating **	M	Issue No.	66	GPS Lat/Long
Issue Type +	Ma	Location *		38.253525 °
Category	Rivers, Channels & Designated Flood			-122.019984 °
Item	Vegetation & Obstructions			
DWR ID	DWR_NA0035_15_c_2012_66			
Action/Comments				
Inspector Comments: Vegetation growth (such as cat tails, bull rushes, bushes or saplings) or other obstructions block approximately 25% of the FCW.

View of the channel looking downstream from Sunset Ave. Summer 2016.

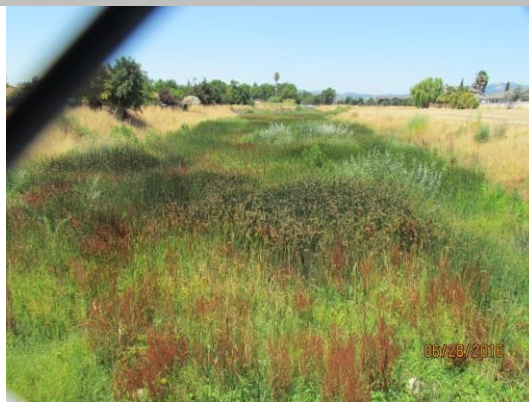
Photo 1 of 2 : CH_2016_NA0035_15_71_20160629_00063.jpg

Rating **	M	Issue No.	71	GPS Lat/Long
Issue Type +	Ma	Location *		38.253382 °
Category	Rivers, Channels & Designated Flood			-122.014862 °
Item	Vegetation & Obstructions			
DWR ID	DWR_NA0035_15_c_2012_71			
Action/Comments				
Inspector Comments: Vegetation growth, cat tails, bushes, or saplings block 25% of the channel.

View of the channel looking upstream from Blossom Rd. Summer 2016.

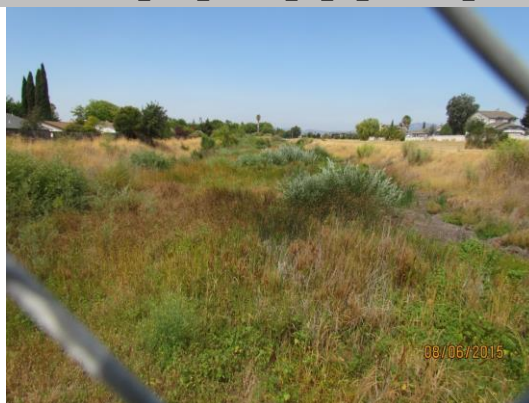
Photo 2 of 2 : CH_2016_NA0035_15_71_20160620_00035.jpg

Looking upstream from Blossom Rd. Summer 2015.

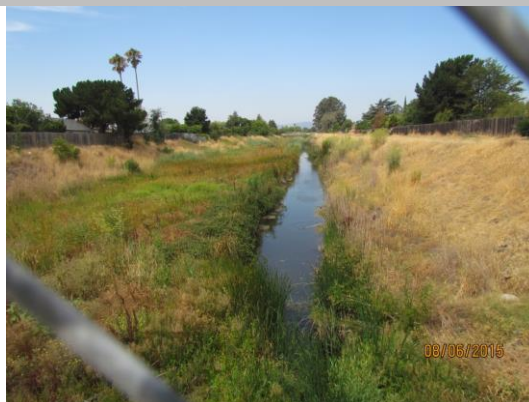
Photo 2 of 2 : CH_2016_NA0035_15_81_20160620_00040.jpg

Looking upstream from Worley Rd. Summer 2015.

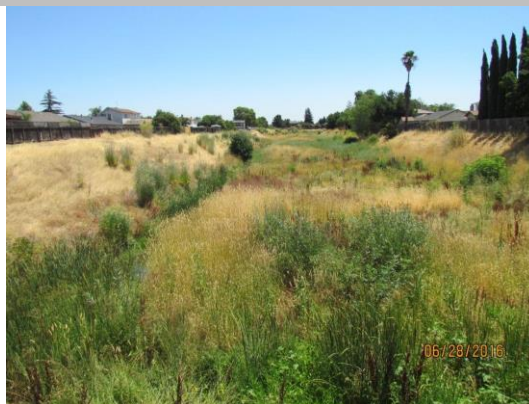
Photo 1 of 2 : CH_2016_NA0035_15_86_20160629_00067.jpg

Rating **	M	Issue No.	86	GPS Lat/Long
Issue Type +	Ma	Location *		38.253311 °
Category	Rivers, Channels & Designated Flood			-122.009841 °
Item	Vegetation & Obstructions			
DWR ID	DWR_NA0035_15_c_2012_86			
Action/Comments				
Inspector Comments: Vegetation growth (such as cat tails, bull rushes, bushes or saplings) or other obstructions block approximately 25% of the FCW.

View of the channel looking downstream from Worley Rd. Summer 2016.

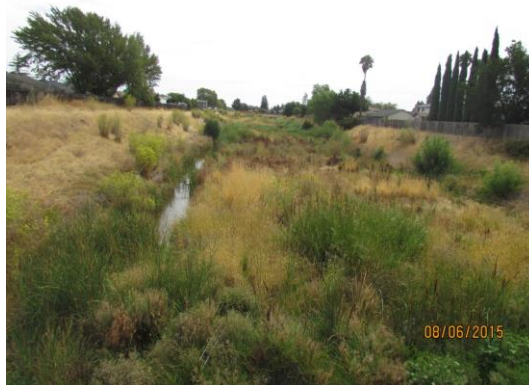
Photo 2 of 2 : CH_2016_NA0035_15_86_20160620_00042.jpg

Looking downstream from Worley Road. Suggest removal of woody vegetation. Summer 2015.

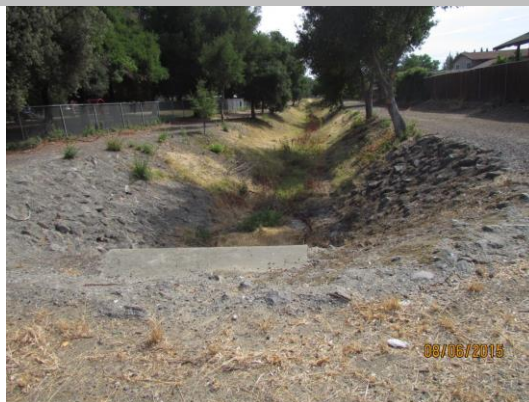
Photo 1 of 2 : CH_2016_NA0035_17_1_20160620_00001.jpg

Rating **	A	Issue No.	1	GPS Lat/Long
Issue Type +	Ma	Location *		38.256296 °
Category	Rivers, Channels & Designated Flood			-122.073705 °
Item	Vegetation & Obstructions			
DWR ID	DWR_NA0035_17_c_2012_1			
Action/Comments				
Inspector Comments: Minimal, scattered obstructions or vegetation.

Looking upstream from Astoria Dr. Trees have been trimmed. Summer 2015.

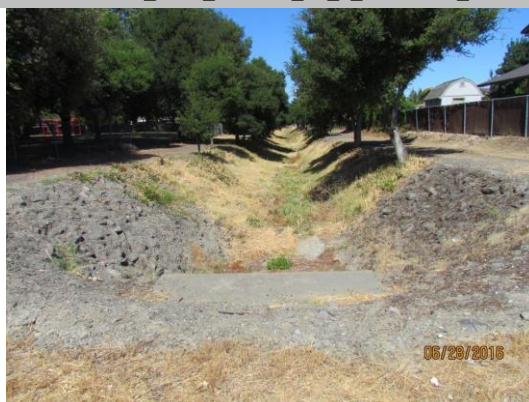
Photo 2 of 2 : CH_2016_NA0035_17_1_20160629_00066.jpg

View of the channel looking upstream from Astoria Dr. Summer 2016.

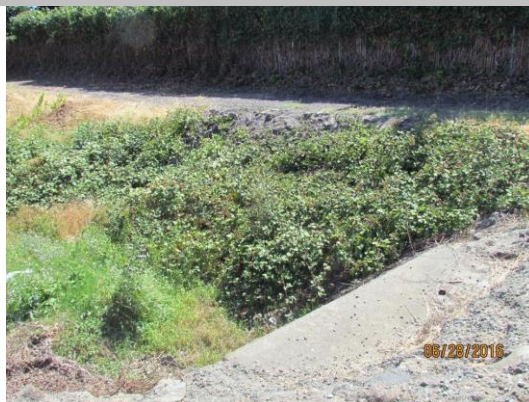
Photo 1 of 3 : CH_2016_NA0035_17_6_20160629_00065.jpg

Rating **	M	Issue No.	6	GPS Lat/Long
Issue Type +	Ma	Location *		38.256296 °
Category	Rivers, Channels & Designated Flood			-122.073705 °
Item	Vegetation & Obstructions			
DWR ID	DWR_NA0035_17_c_2012_6			
Action/Comments				
Inspector Comments: Blackberries need to be removed. Can impede the channel.

Blackberries on the downstream side of Astoria Dr. need to be removed. Summer 2016.

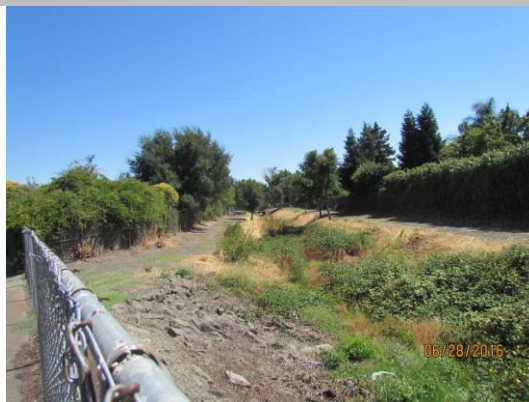
Photo 2 of 3 : CH_2016_NA0035_17_6_20160629_00064.jpg

View of the channel looking downstream from Astoria Dr. Summer 2016.

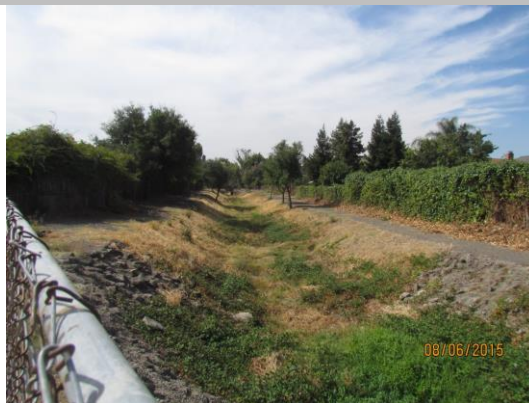
Photo 3 of 3 : CH_2016_NA0035_17_6_20160620_00003.jpg

Looking downstream from Astoria Dr. Summer 2015.

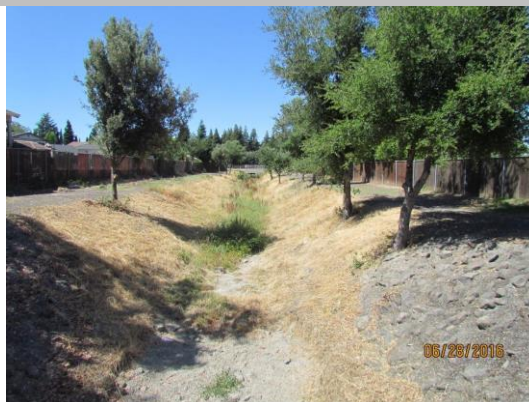
Photo 1 of 2 : CH_2016_NA0035_17_11_20160629_00063.jpg

Inspector Comments: Minimal, scattered obstructions or vegetation. The flow is not impeded.

View of the channel looking upstream from Springfield Dr. Summer 2016.

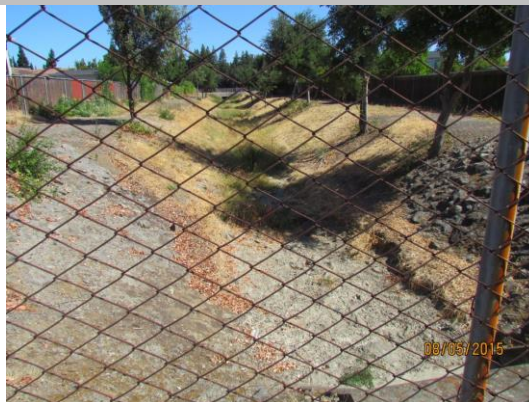
Photo 2 of 2 : CH_2016_NA0035_17_11_20160620_00006.jpg

Looking upstream from Springfield Dr. Summer 2015.

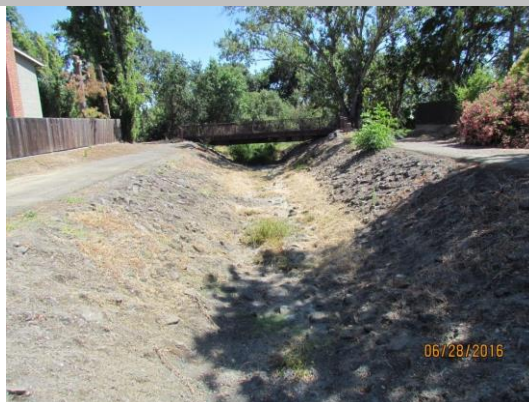
Photo 1 of 2 : CH_2016_NA0035_17_16_20160629_00062.jpg

Check Point / View				
Springfield Dr. / Down				
Rating **	A	Issue No.	16	GPS Lat/Long
Issue Type +	Ma	Location *		38.254594 °
Category	Rivers, Channels & Designated Flood			-122.073608 °
Item	Vegetation & Obstructions			
DWR ID	DWR_NA0035_17_c_2012_16			
Action/Comments				
Inspector Comments: Minimal, scattered obstructions or vegetation. The flow is not impeded.

View of the channel looking downstream from Springfield Dr. Summer 2016.

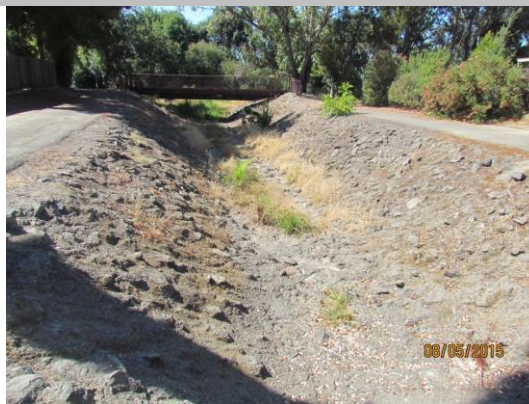
Photo 2 of 2 : CH_2016_NA0035_17_16_20160620_00008.jpg

Rating **	A	Issue No.	16 (cont)	GPS Lat/Long
Issue Type +	Ma	Location *		38.254594 °
Category	Rivers, Channels & Designated Flood			-122.073608 °
Item	Vegetation & Obstructions			
DWR ID	DWR_NA0035_17_c_2012_16			
Action/Comments				
Inspector Comments: Minimal, scattered obstructions or vegetation. The flow is not impeded.

Looking downstream from Springfield Dr. Summer 2015.

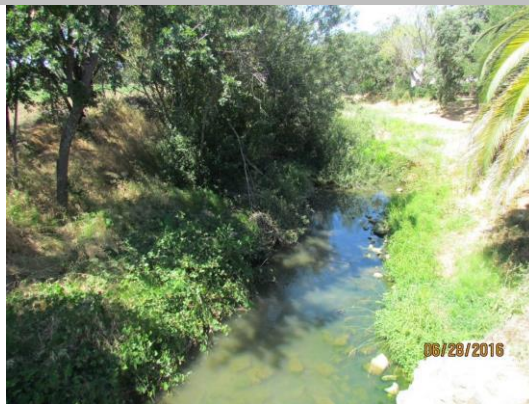
Photo 1 of 2 : CH_2016_NA0035_17_21_20160629_00061.jpg

Inspector Comments: Minimal, scattered obstructions or vegetation. The flow is not impeded.

View of the channel looking upstream from Rockville Rd. Summer 2016.

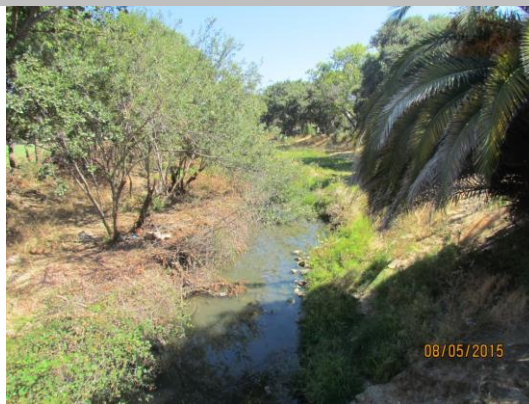
Photo 2 of 2 : CH_2016_NA0035_17_21_20160620_00010.jpg

Inspector Comments: Minimal, scattered obstructions or vegetation. The flow is not impeded.

Looking upstream from Rockville Rd. Summer 2015.

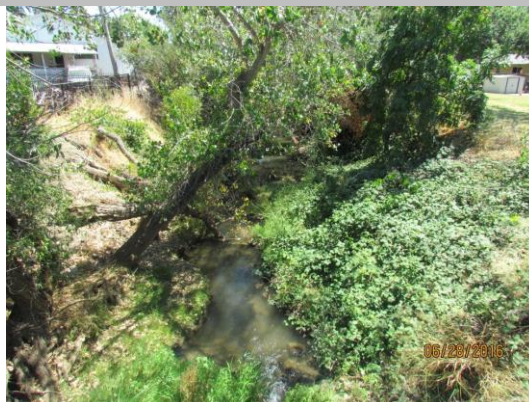
Photo 1 of 2 : CH_2016_NA0035_17_26_20160629_00059.jpg

Rating **	A	Issue No.	26	GPS Lat/Long
Issue Type +	Ma	Location *		38.249840 °
Category	Rivers, Channels & Designated Flood			-122.072644 °
Item	Vegetation & Obstructions			
DWR ID	DWR_NA0035_17_c_2012_26			
Action/Comments				
Inspector Comments: Minimal, scattered obstructions or vegetation. The flow is not impeded.

View of the channel looking downstream from Rockville Rd. Summer 2016.

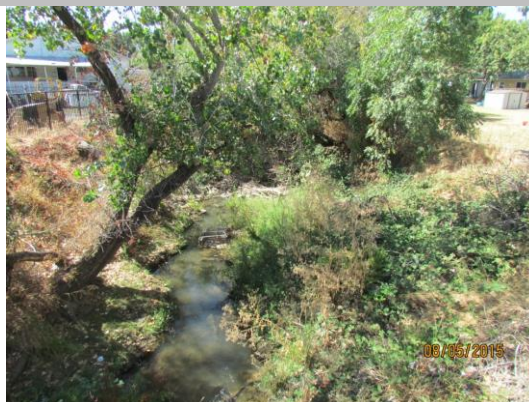
Photo 2 of 2 : CH_2016_NA0035_17_26_20160620_00014.jpg

Looking downstream from Rockville Rd. Summer 2015.

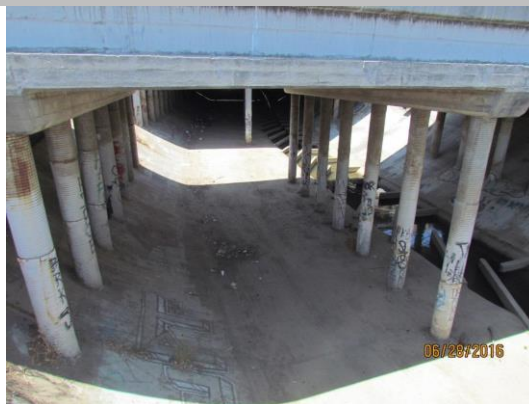
Photo 1 of 2 : CH_2016_NA0035_17_31_20160629_00058.jpg

Rating **	A	Issue No.	31	GPS Lat/Long
Issue Type +	Ma	Location *		38.247663 °
Category	Rivers, Channels & Designated Flood			-122.071997 °
Item	Vegetation & Obstructions			
DWR ID	DWR_NA0035_17_c_2012_31			
Action/Comments				
Inspector Comments: Minimal, scattered obstructions or vegetation. The flow is not impeded.

View of the channel looking upstream from Auto Mall Pkwy. Summer 2016.

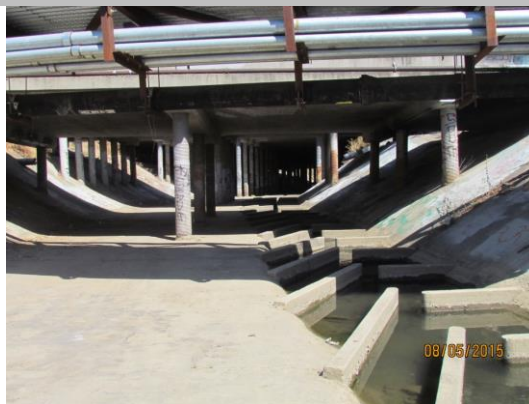
Photo 2 of 2 : CH_2016_NA0035_17_31_20160620_00016.jpg

Looking upstream from Auto Mall Pkwy under I-80. Summer 2015.

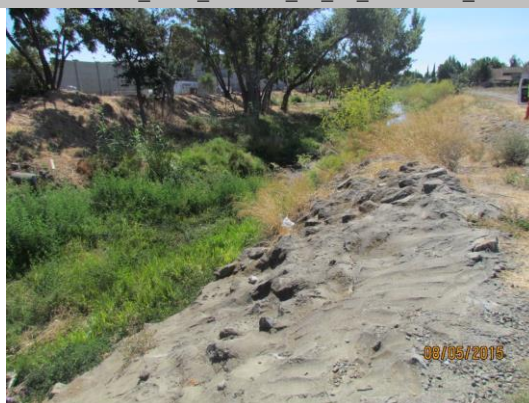
Photo 3 of 3 : CH_2016_NA0035_17_36_20160620_00018.jpg

Looking downstream from Auto Mall Pkwy. Summer 2015.

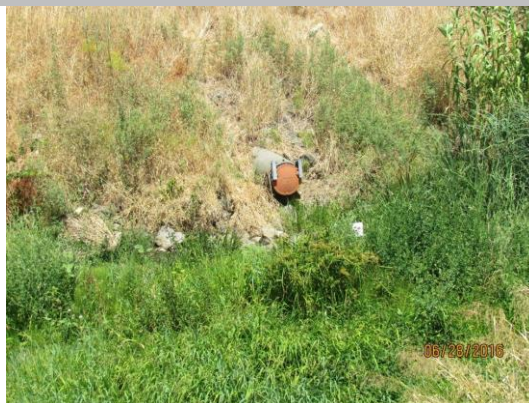
Photo 1 of 2 : CH_2016_NA0035_17_82_20160629_00057.jpg

View of the gate on the downstream side of the channel from Auto Mall Pkwy. Summer 2016.

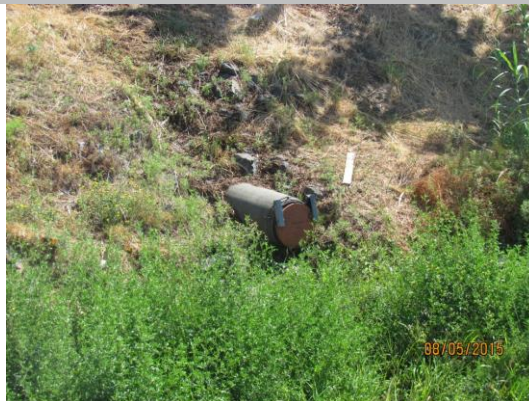
Photo 2 of 2 : CH_2016_NA0035_17_82_20160620_00041.jpg

View of the gate looking downstream from Auto Mall Pkwy. Summer 2015.

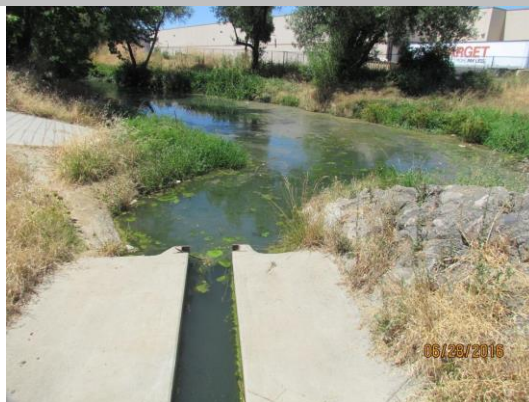
Photo 1 of 3 : CH_2016_NA0035_17_41_20160629_00053.jpg

Rating **	A	Issue No.	41	GPS Lat/Long
Issue Type +	Ma	Location *		38.245298 °
Category	Rivers, Channels & Designated Flood			-122.068536 °
Item	Vegetation & Obstructions			
DWR ID	DWR_NA0035_17_c_2012_41			
Action/Comments				
Inspector Comments: Minimal, scattered obstructions or vegetation. The flow is not impeded.

View of the inlet of the historical channel looking upstream from Woolner Ave. Summer 2016.

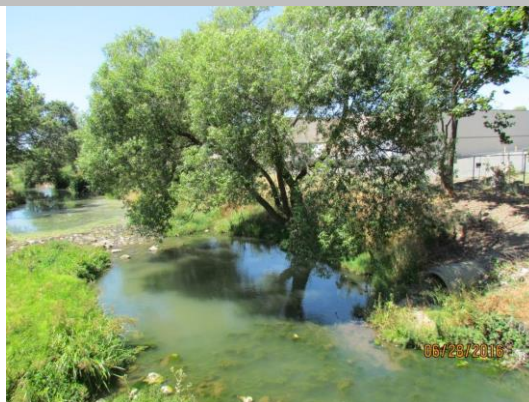
Photo 2 of 3 : CH_2016_NA0035_17_41_20160629_00052.jpg

View of the channel looking upstream from Woolner Ave. Cart has been removed. Summer 2016.

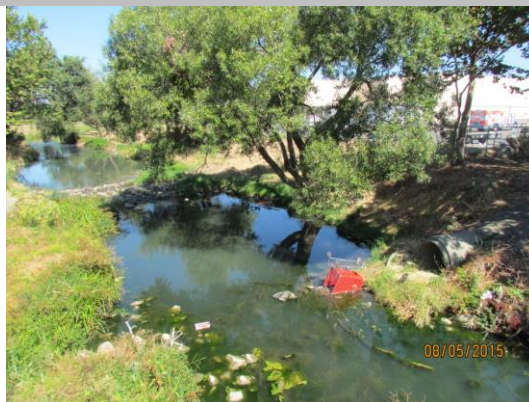
Photo 3 of 3 : CH_2016_NA0035_17_41_20160620_00020.jpg

Inspector Comments: Minimal, scattered obstructions or vegetation. The flow is not impeded.

Looking upstream from Woolner Ave. Suggest removing cart from the channel. Summer 2015.

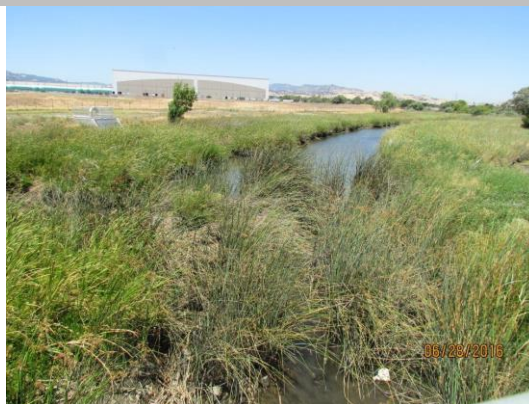
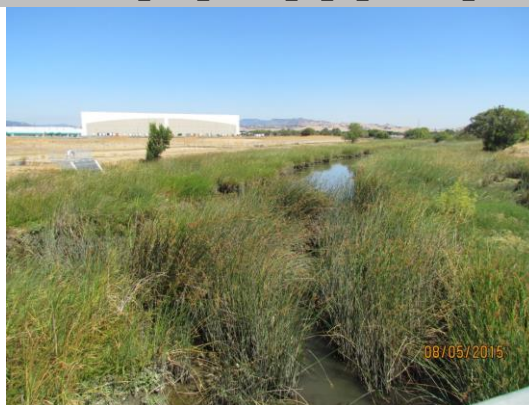
Inspector Comments: Vegetation growth of cattails or other obstruction impede the flow.

View of the channel looking upstream from Cordelia Rd. Summer 2016.

Looking upstream from Cordelia Rd. Summer 2015.

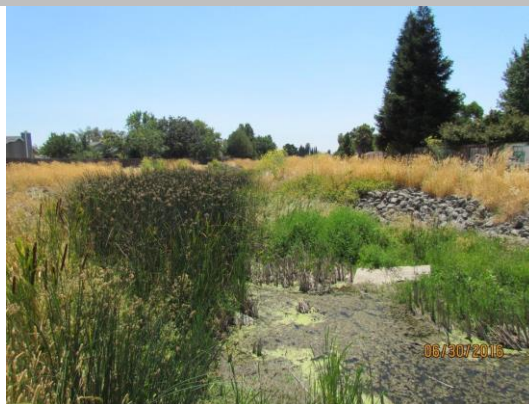
Photo 1 of 2 : CH_2016_NA0035_14_6_20160707_00020.jpg

Rating **	M	Issue No.	6	GPS Lat/Long
Issue Type +	Ma	Location *		38.253280 °
Category	Rivers, Channels & Designated Flood			-122.000670 °
Item	Vegetation & Obstructions			
DWR ID	DWR_NA0035_14_c_2012_6			
Action/Comments				
Inspector Comments: Vegetation growth (such as cat tails, bull rushes, bushes or saplings) or other obstructions block approximately 25% of the capacity.

View of the creek looking downstream at the end of Bella Vista Ave. Summer 2016.

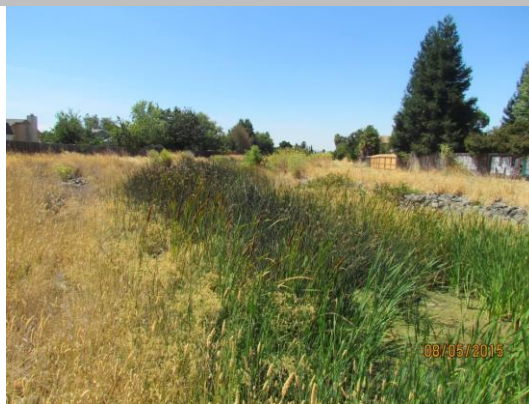
Photo 2 of 2 : CH_2016_NA0035_14_6_20160620_00003.jpg

View of the vegetation looking downstream. Summer 2015.

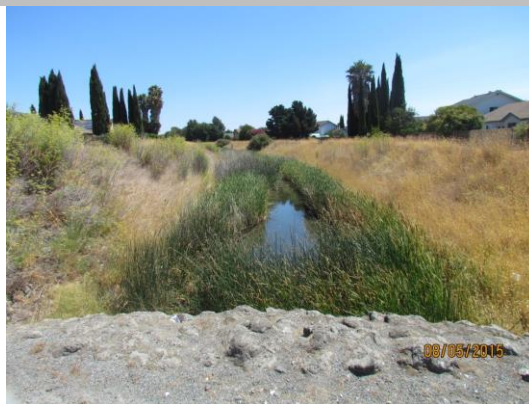
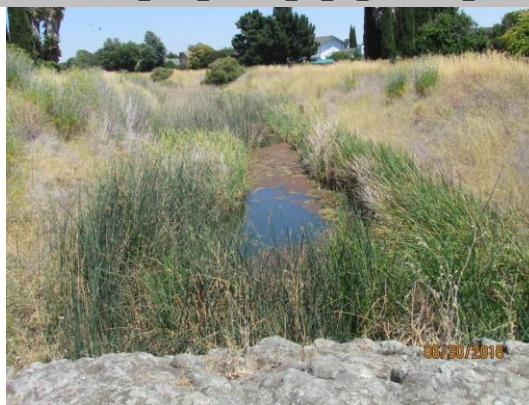
View of the channel looking upstream. Summer 2015.

View of the creek looking upstream from Emperor Dr. Summer 2016.

Inspector Comments: Cat-tails need to be sprayed or removed at street crossing.

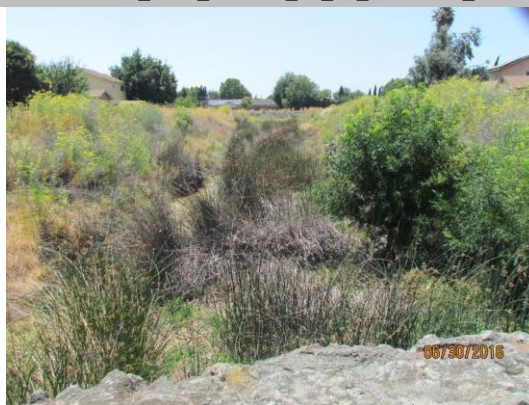
Photo 2 of 3 : CH_2016_NA0035_14_16_20160707_00022.jpg

View of the creek looking downstream from Emperor Dr. Summer 2016.

Remove woody vegetation from the creek. Summer 2016.

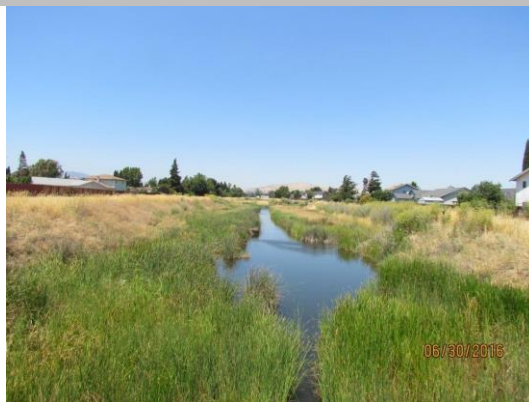
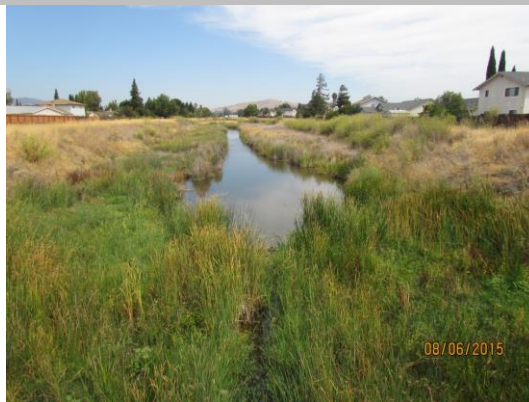
Rating **	A	Issue No.	21	GPS Lat/Long
Issue Type +	Ma	Location *		38.248542 °
Category	Rivers, Channels & Designated Flood			-122.006378 °
Item	Vegetation & Obstructions			
DWR ID	DWR_NA0035_14_c_2012_21			
Action/Comments				
Inspector Comments: Minimal scattered obstruction or vegetation. The flow is not impeded. Monitor excessive vegetation growth.

View of the creek looking upstream from Pintail Dr. Summer 2016.

View of the channel looking upstream. Summer 2015.

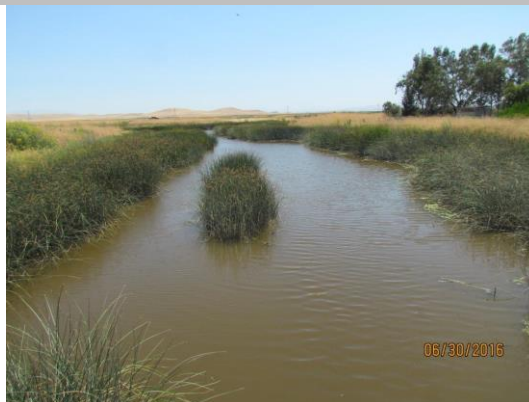
Photo 1 of 2 : CH_2016_NA0035_14_36_20160707_00027.jpg

Inspector Comments: Minimal, scattered obstructions or vegetation. The flow is not impeded.

View of the creek looking downstream towards Suisun Bay from Anderson Dr. Summer 2016.

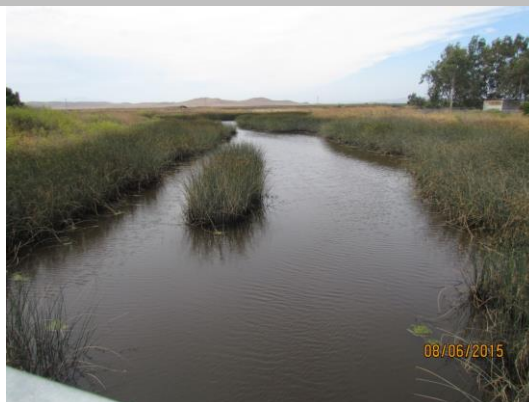
Photo 2 of 2 : CH_2016_NA0035_14_36_20160620_00017.jpg

Rating **	A	Issue No.	36 (cont)	GPS Lat/Long
Issue Type +	Ma	Location *		38.241537 °
Category	Rivers, Channels & Designated Flood			-122.012077 °
Item	Vegetation & Obstructions			
DWR ID	DWR_NA0035_14_c_2012_36			
Action/Comments				
Inspector Comments: Minimal, scattered obstructions or vegetation. The flow is not impeded.

View of the channel looking downstream. Summer 2015.

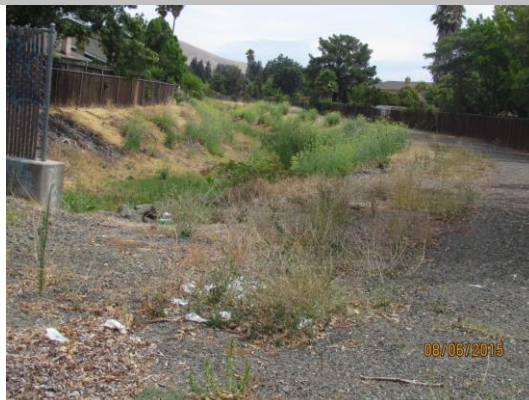
Photo 3 of 3 : CH_2016_NA0035_16_6_20160620_00001.jpg

Looking downstream from N. Texas St. Summer 2015.

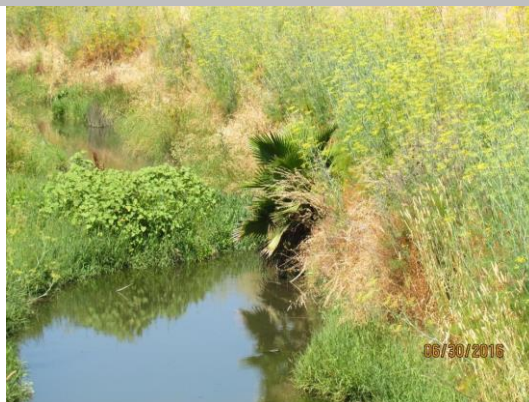
Photo 1 of 3 : CH_2016_NA0035_16_11_20160707_00021.jpg

Inspector Comments: Minimal, scattered obstructions or vegetation. The flow is not impeded.

Remove volunteer palm trees from the channel. Summer 2016.

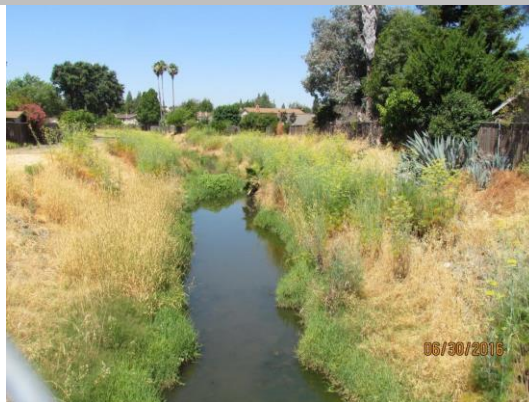
Photo 2 of 3 : CH_2016_NA0035_16_11_20160707_00020.jpg

View of the channel looking upstream from Camrose Ave. Summer 2016.

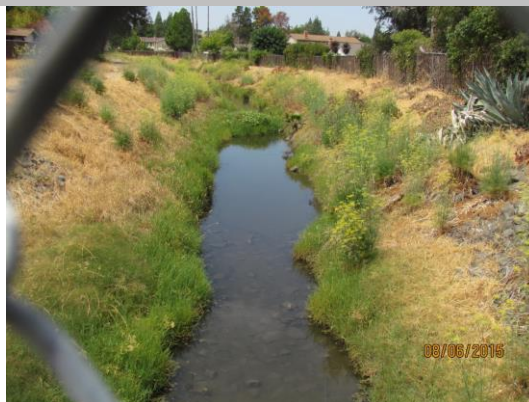
Photo 3 of 3 : CH_2016_NA0035_16_11_20160620_00004.jpg

Check Point / View				
Camrose Ave / Up (cont)				
Rating **	A	Issue No.	11 (cont)	GPS Lat/Long
Issue Type +	Ma	Location *		38.281668 °
Category	Rivers, Channels & Designated Flood			-122.030495 °
Item	Vegetation & Obstructions			
DWR ID	DWR_NA0035_16_c_2012_11			
Action/Comments				
Inspector Comments: Minimal, scattered obstructions or vegetation. The flow is not impeded.

Looking upstream from Camrose Ave. Summer 2015.

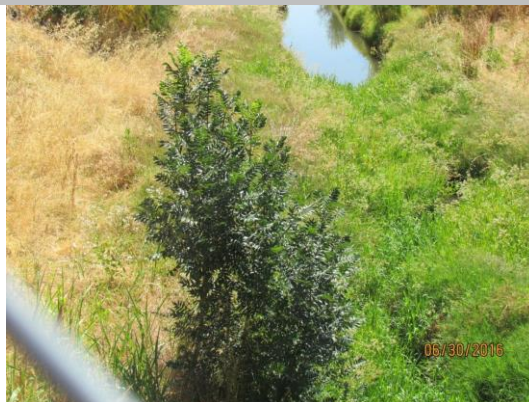
Photo 1 of 3 : CH_2016_NA0035_16_16_20160707_00023.jpg

Inspector Comments: Minimal, scattered obstructions or vegetation. The flow is not impeded.

Remove woody vegetation. Summer 2016.

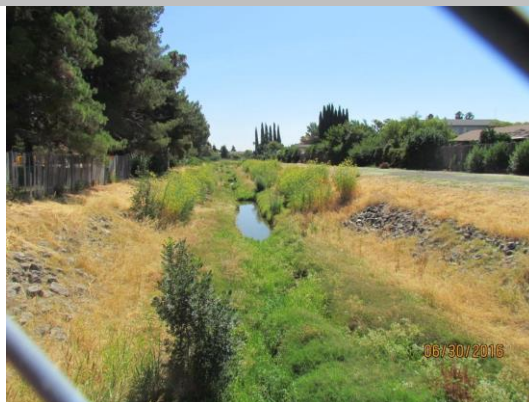
Photo 2 of 3 : CH_2016_NA0035_16_16_20160707_00022.jpg

Inspector Comments: Minimal, scattered obstructions or vegetation. The flow is not impeded.

View of the channel looking downstream from Camrose Ave. Summer 2016.

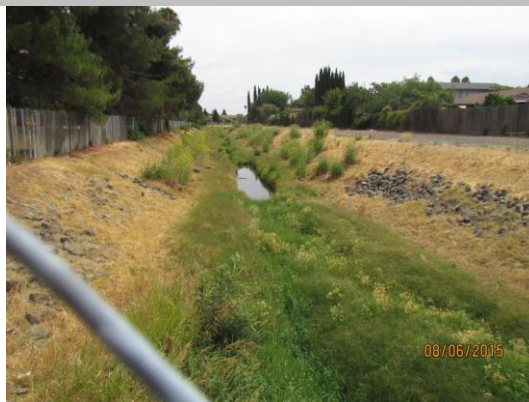
Photo 3 of 3 : CH_2016_NA0035_16_16_20160620_00007.jpg

Looking downstream from Camrose Ave. Summer 2015.

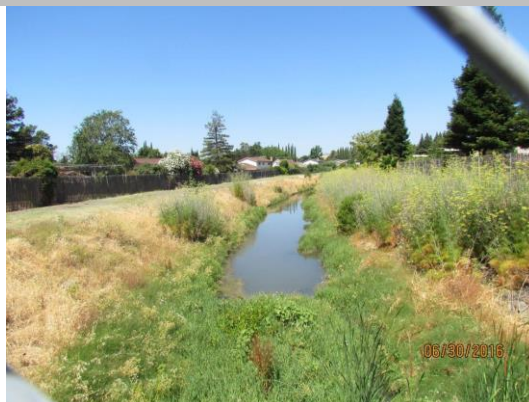
Photo 1 of 2 : CH_2016_NA0035_16_21_20160707_00024.jpg

Inspector Comments: Minimal, scattered obstructions or vegetation. The flow is not impeded.

View of the channel looking upstream from Dover Ave. Summer 2016.

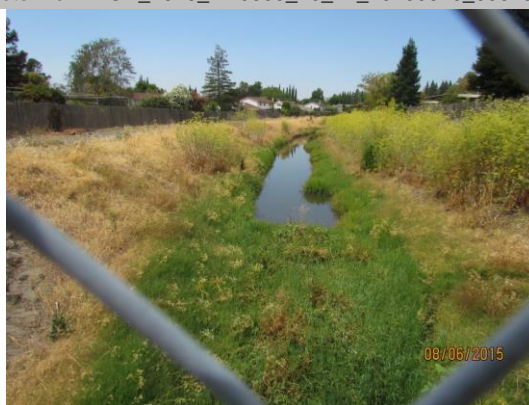
Photo 2 of 2 : CH_2016_NA0035_16_21_20160620_00010.jpg

Looking upstream from Dover Ave. Summer 2015.

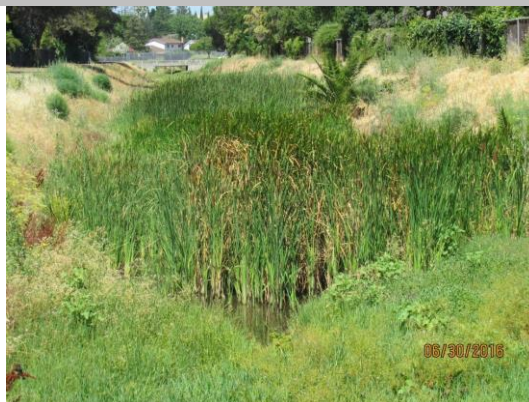
Photo 1 of 3 : CH_2016_NA0035_16_31_20160707_00028.jpg

Check Point / View				
Gulf Dr / Up				
Rating **	M	Issue No.	31	GPS Lat/Long
Issue Type +	Ma	Location *		38.280937 °
Category	Rivers, Channels & Designated Flood			-122.020628 °
Item	Vegetation & Obstructions			
DWR ID	DWR_NA0035_16_c_2012_31			
Action/Comments				
Inspector Comments: Log jams, snags, vegetation growth (such as cat tails, bull rushes, bushes or saplings) or other obstructions block approximately 25% of the capacity.

Remove unwanted vegetation and palm tree from the diversion. Summer 2016.

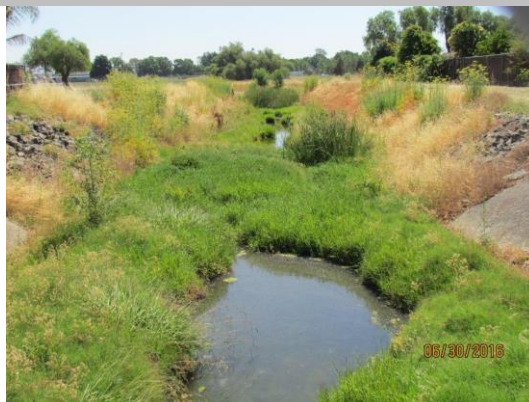
Photo 1 of 2 : CH_2016_NA0035_16_36_20160707_00029.jpg

Rating **	A	Issue No.	36	GPS Lat/Long
Issue Type +	Ma	Location *		38.280937 °
Category	Rivers, Channels & Designated Flood			-122.020629 °
Item	Vegetation & Obstructions			
DWR ID	DWR_NA0035_16_c_2012_36			
Action/Comments				
Inspector Comments: Minimal, scattered obstructions or vegetation. The flow is not impeded.

View of the channel looking downstream from Gulf Dr. Summer 2016.

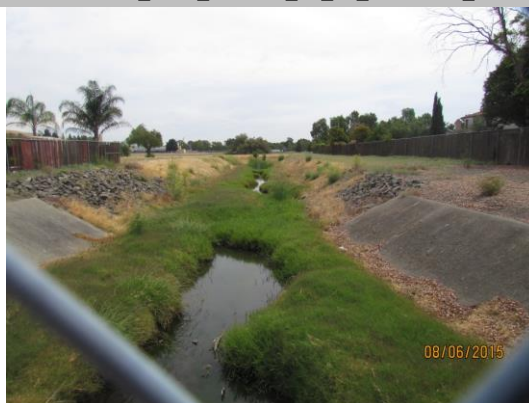
Photo 2 of 2 : CH_2016_NA0035_16_36_20160620_00016.jpg

Looking downstream from Gulf Dr. Summer 2015.
